ELECTRICAL LOAD STUDY & POWER QUALITY ANALYSIS REPORT

**AUTOMOTIVE COMPONENT
MANUFACTURING COMPANY**

SAS Powertech Pvt Ltd.

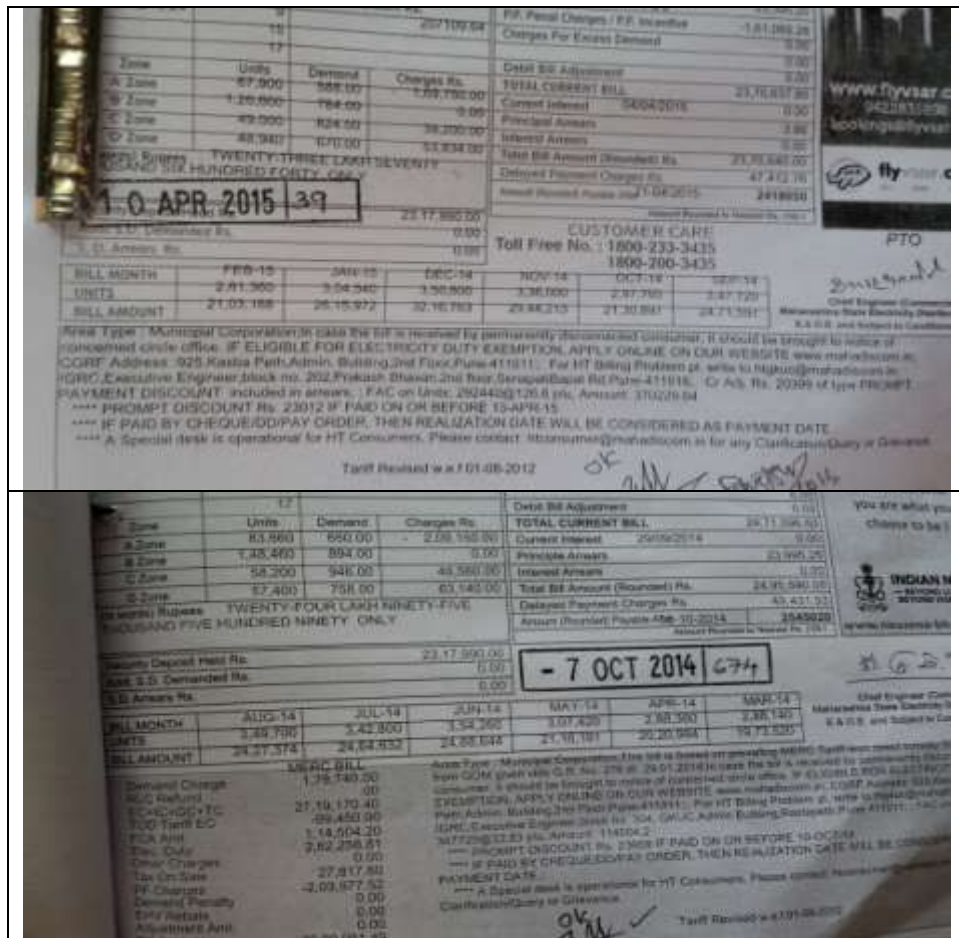
These are photographs of MSEDCL bills.

From March 14 to Feb 15, 354000Kwh is maximum consumption.

With 22hours per day and 22 days in a month, this suggests average consumption of 750KW.

The contract demand is 1130KVA and MD recorded is around 950KVA.

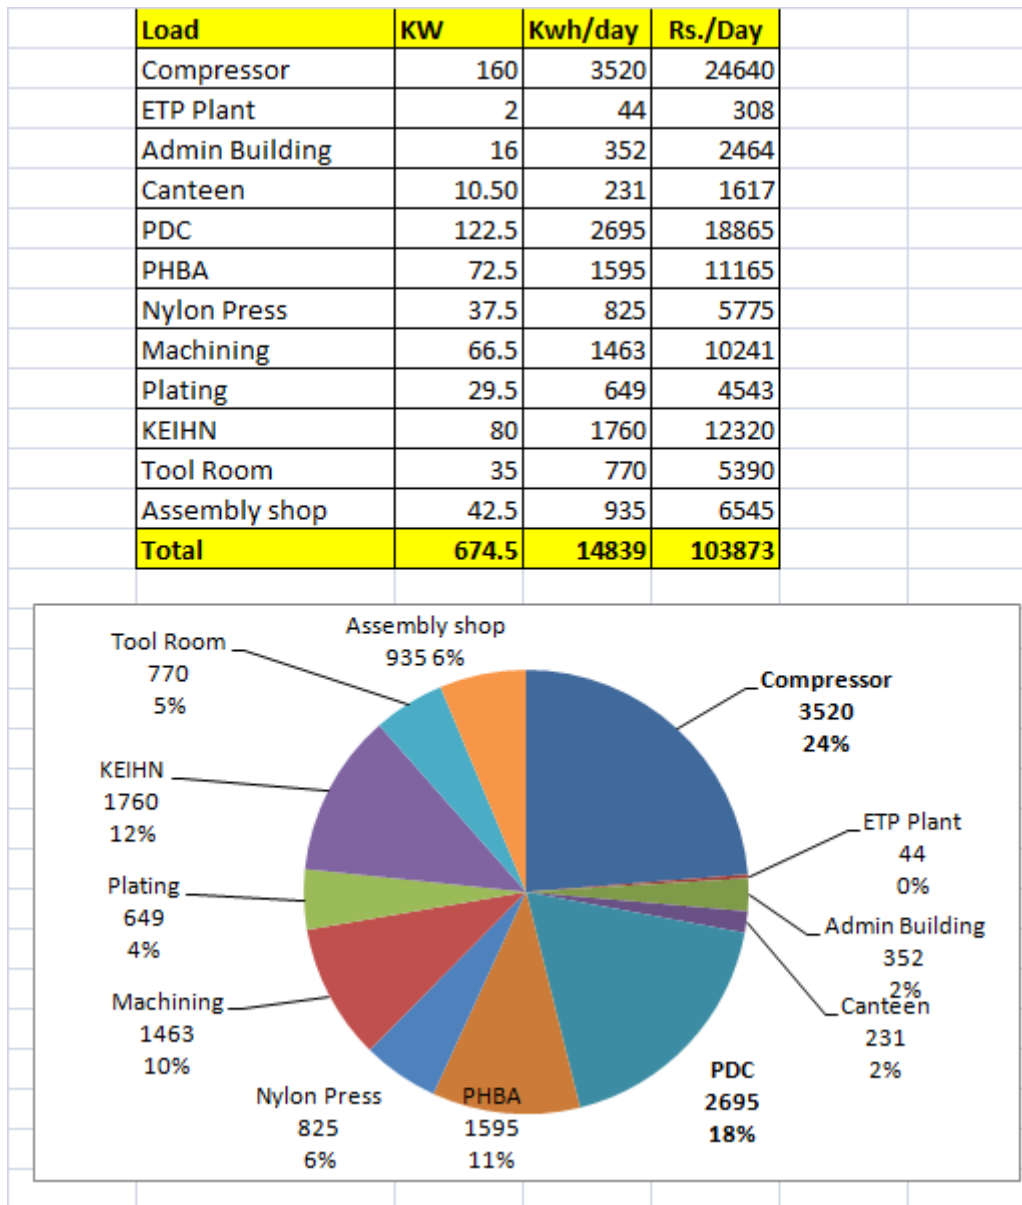
Section wise energy consumption

- **At Spaco, daily cost of electrical energy is around Rs.1Lac.**
- 25% of this is spent on compressed air, while 18% is spent on PDC operation. PDC section consumes PNG for aluminium and zinc melting.
- Accounting for this, top two energy consuming sections would be PDC and Compressed air.
- Any energy saving projects must run in these two sections to give noticeable impact.
- Plant runs in three shifts. So illumination load also must be substantial. You may think about energy efficient light fittings like LED's and induction lamps as per application areas.

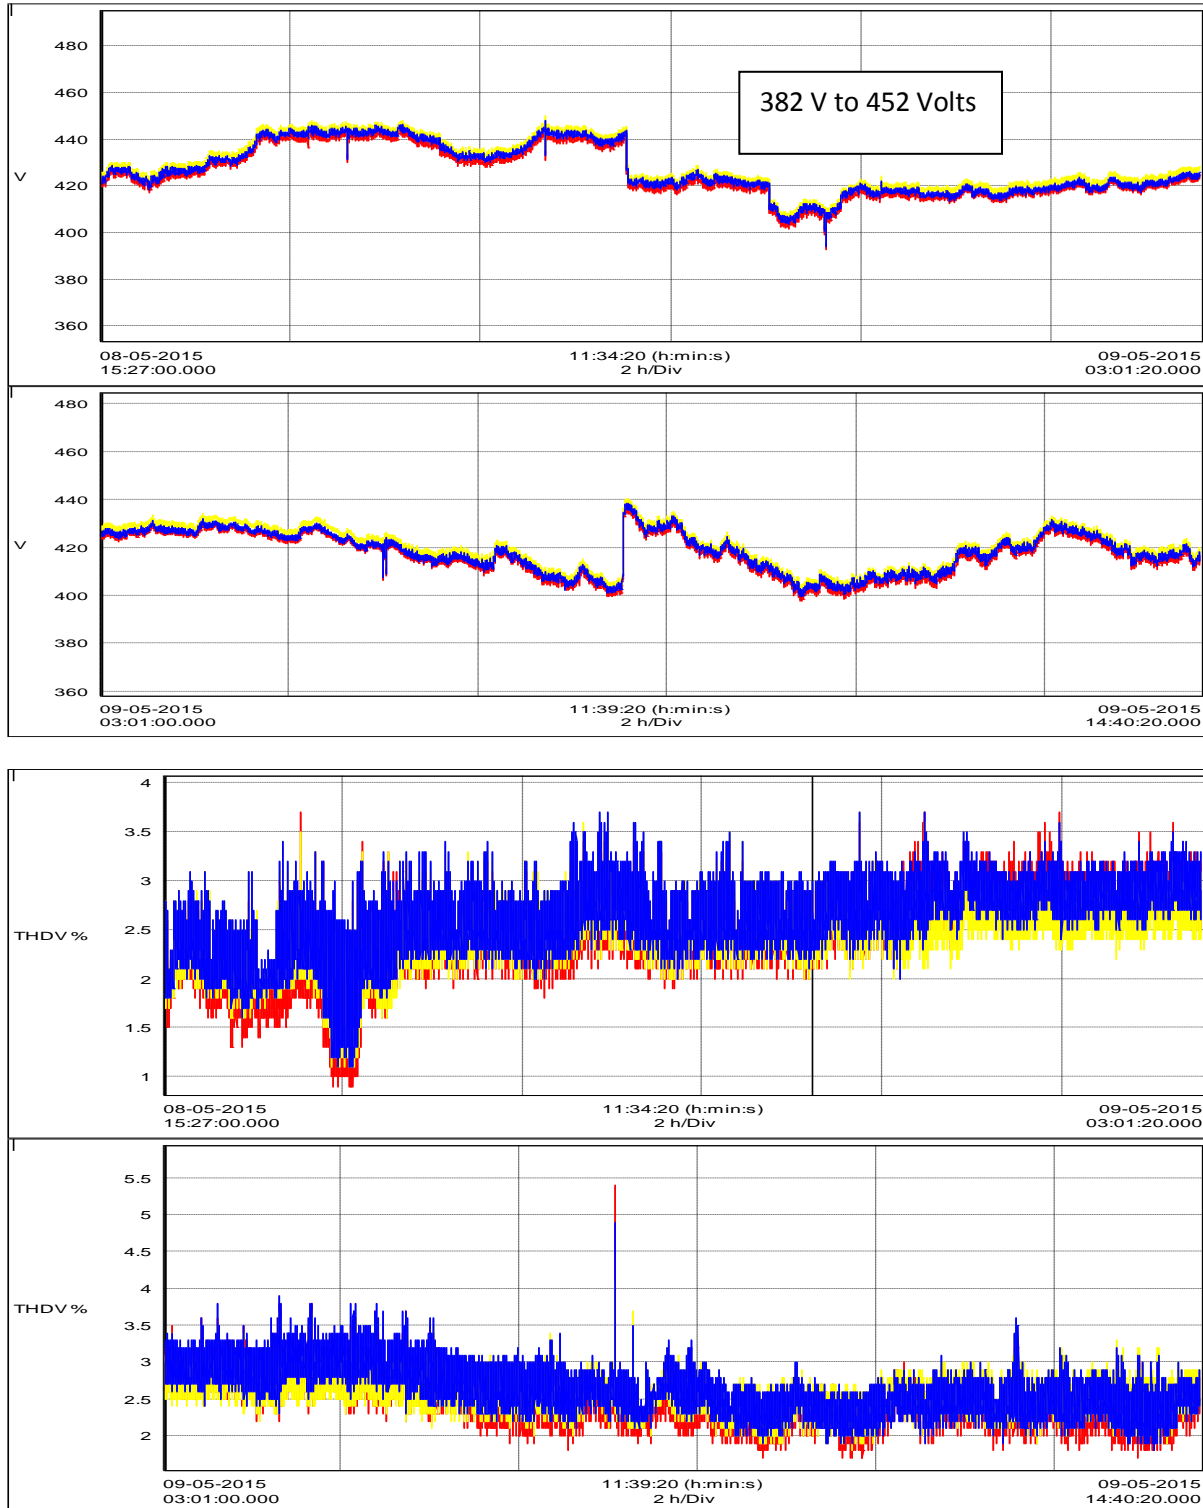
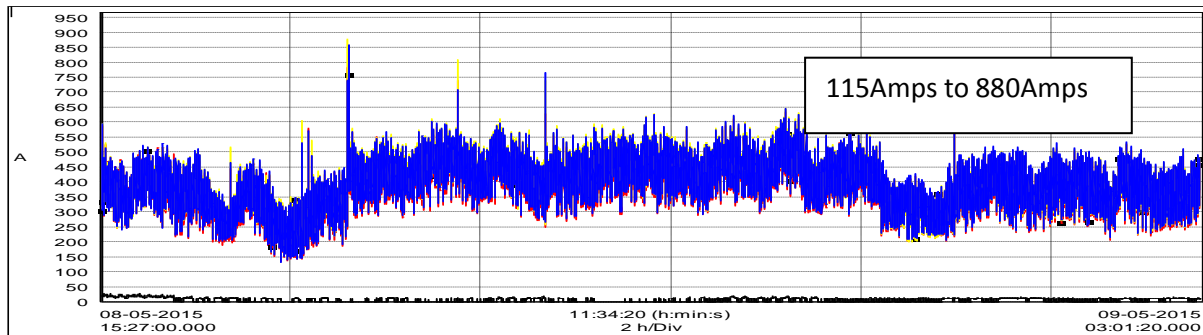
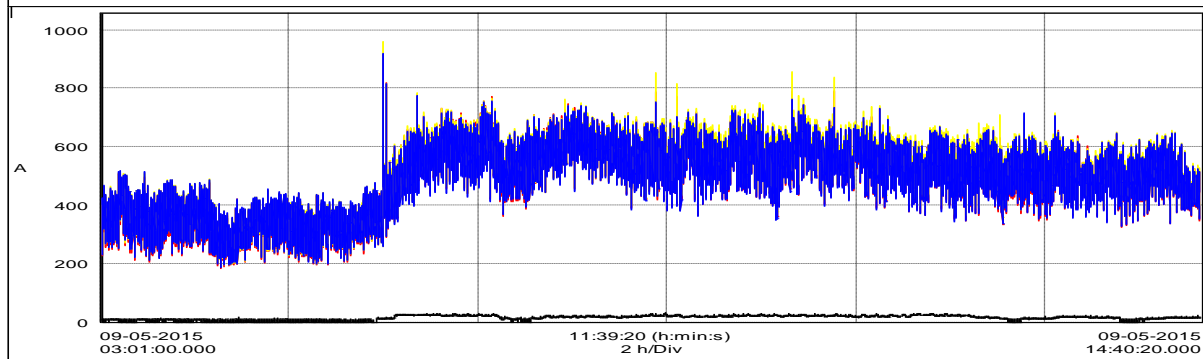
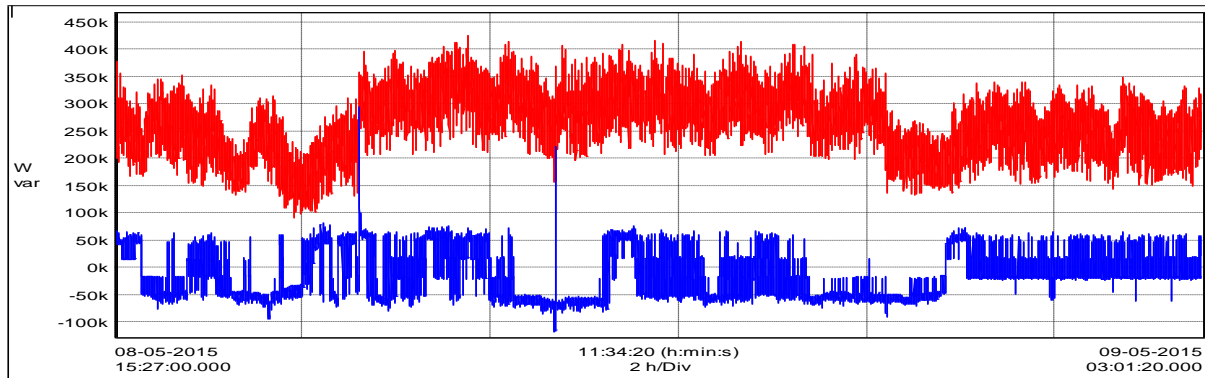
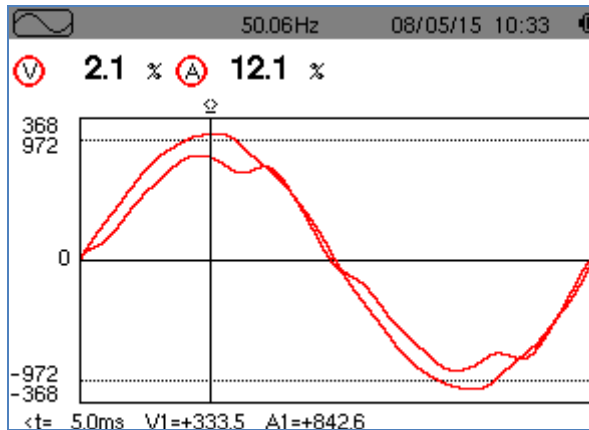
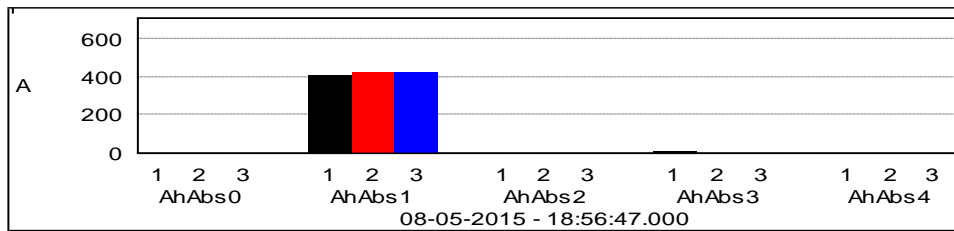
Transformer 1 (PDC)

- 1) Voltage remains within 400V to 450V RMS with tap-changer upstream. Voltage harmonic distortion is less than 3.5%. These readings are recorded continuously over 24 hours with each reading collected at 1 sec interval. Frequency is stable at around 50Hz.
- 2) This 500KVA transformer handles about 750Amps current and the same is distorted at 25%. So effective current can be considered as 900Amps. **Effective Peak power delivery with these parameters is over 600 KVA. This transformer is clearly overloaded.** Most of the time actual RMS wattage handled by this transformer is also almost 450KW.
- 3) The APFC panel maintains reactive power correction to -50KVAR level always. Harmonic analysis shows predominance of 5th and 7th harmonic currents. Reflected HT side current harmonics may be slightly less.

- It is also observed that about 200KW load is related to compressors which are working on transformer 1 along with other PDC Load. This may be split within other transformers, so that Transformer 1 will not get overloaded.

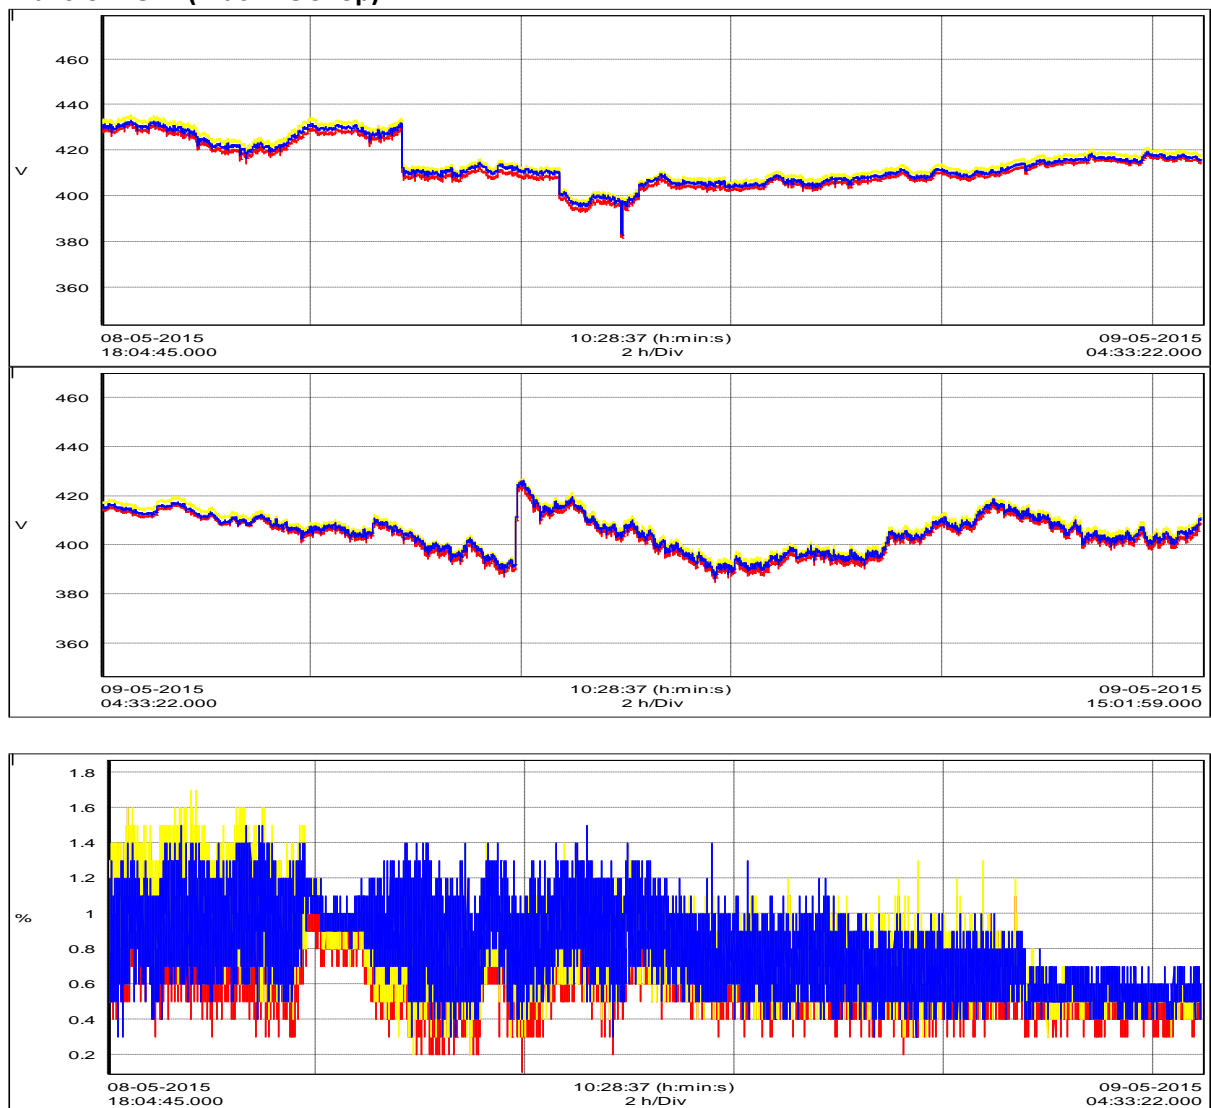
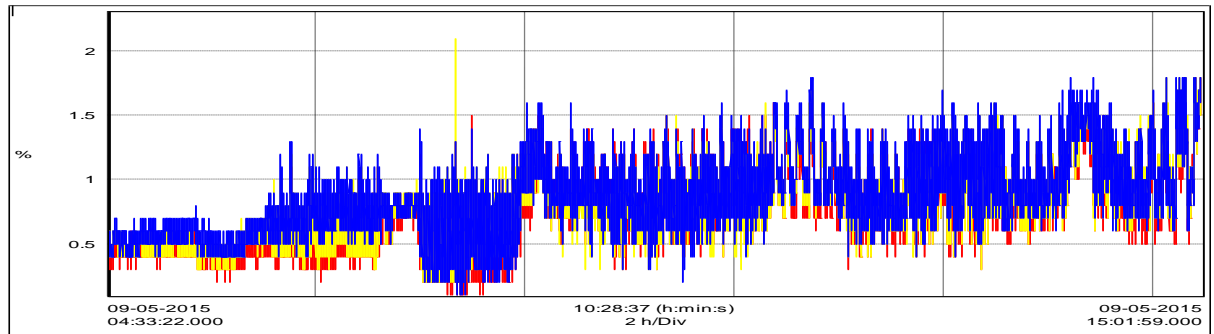
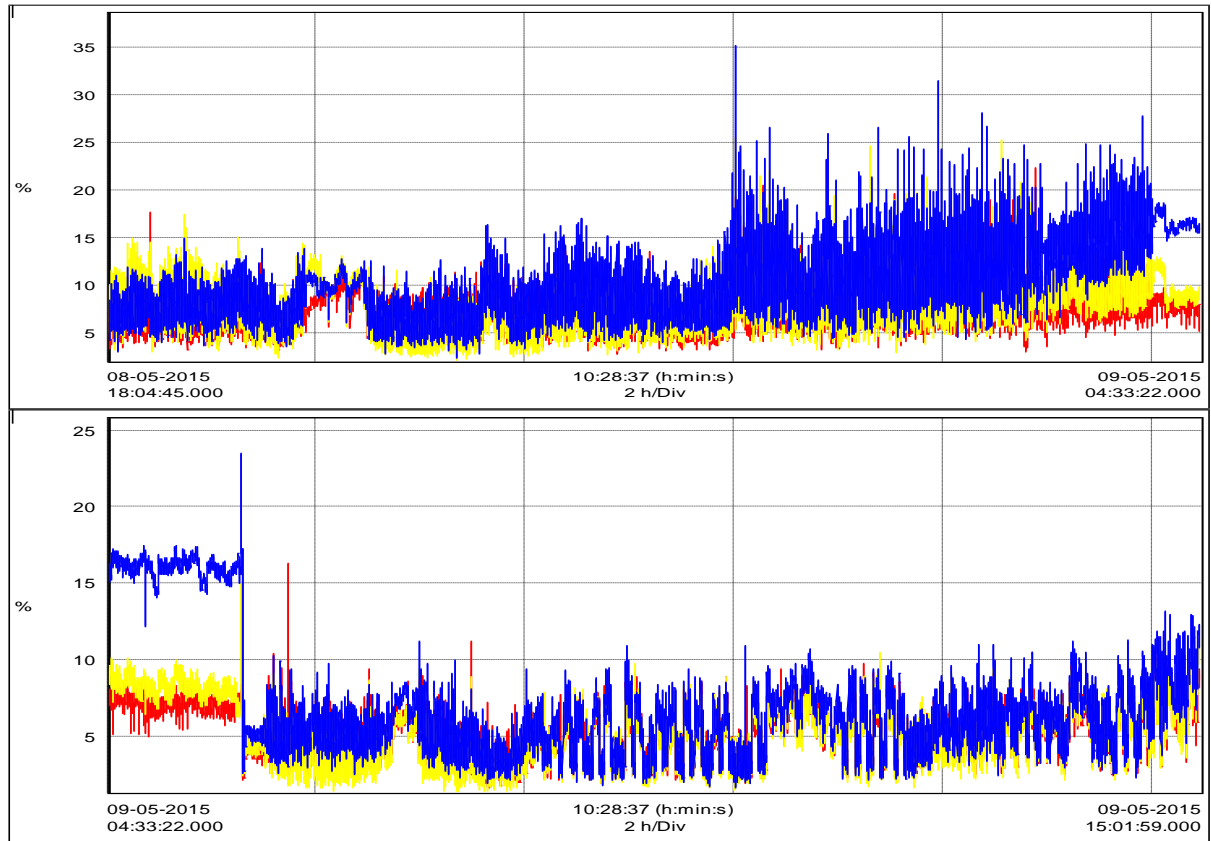
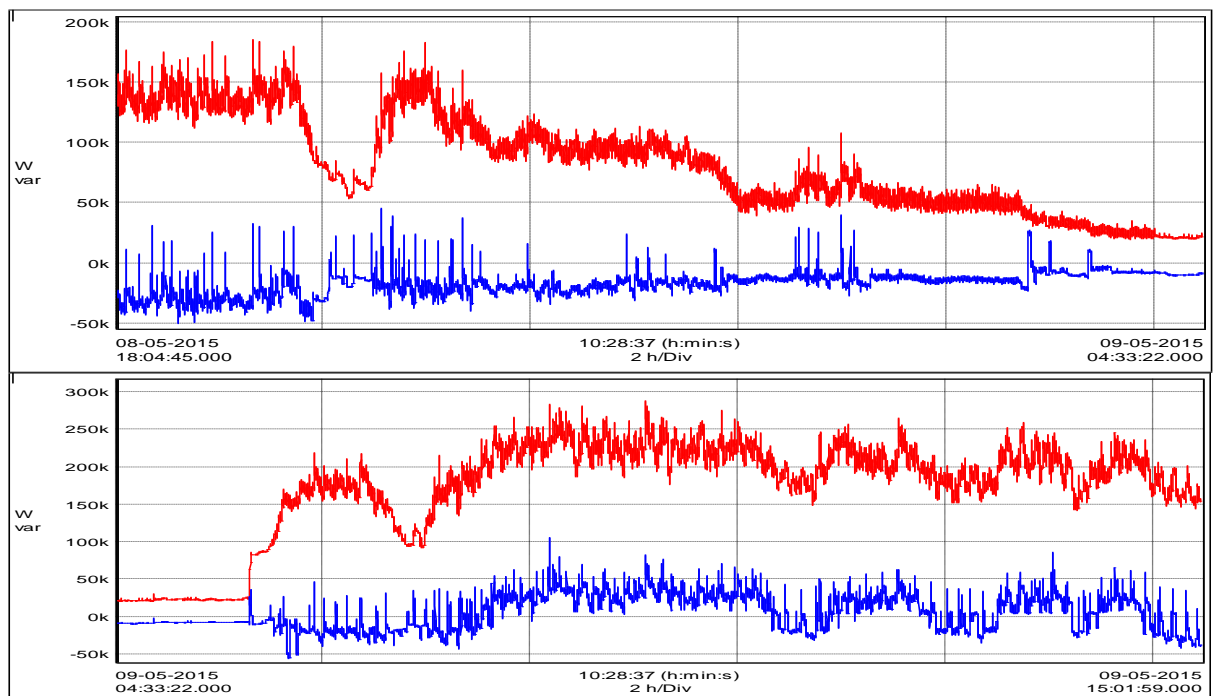
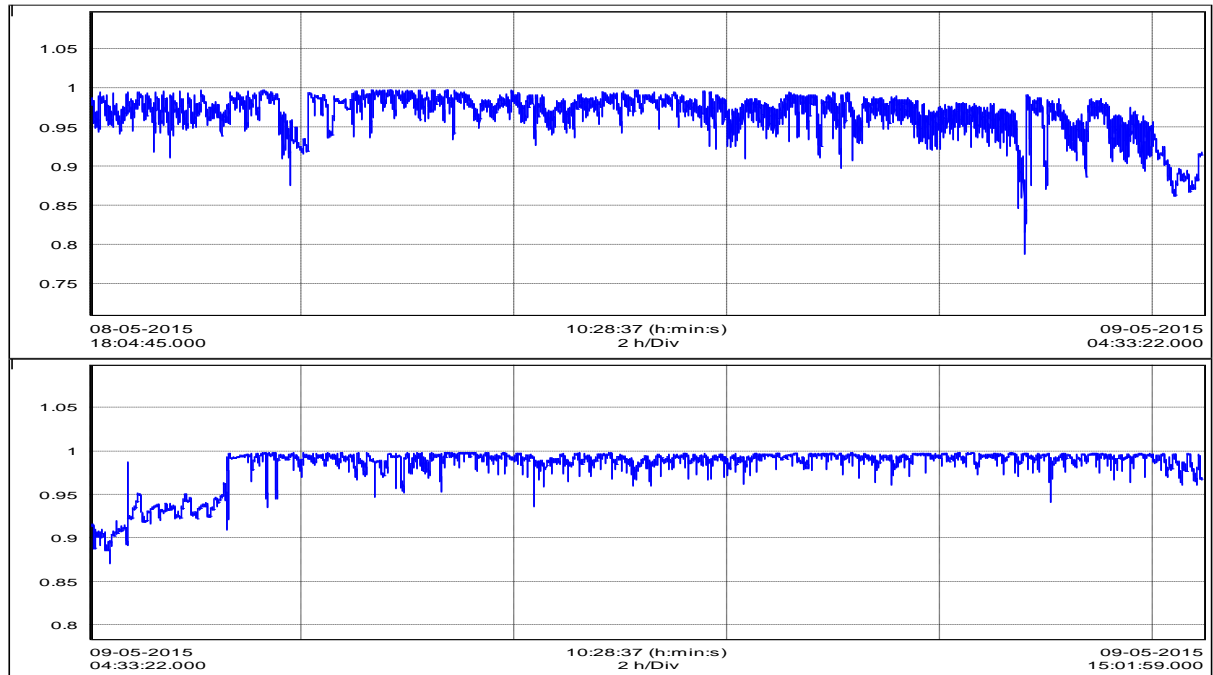
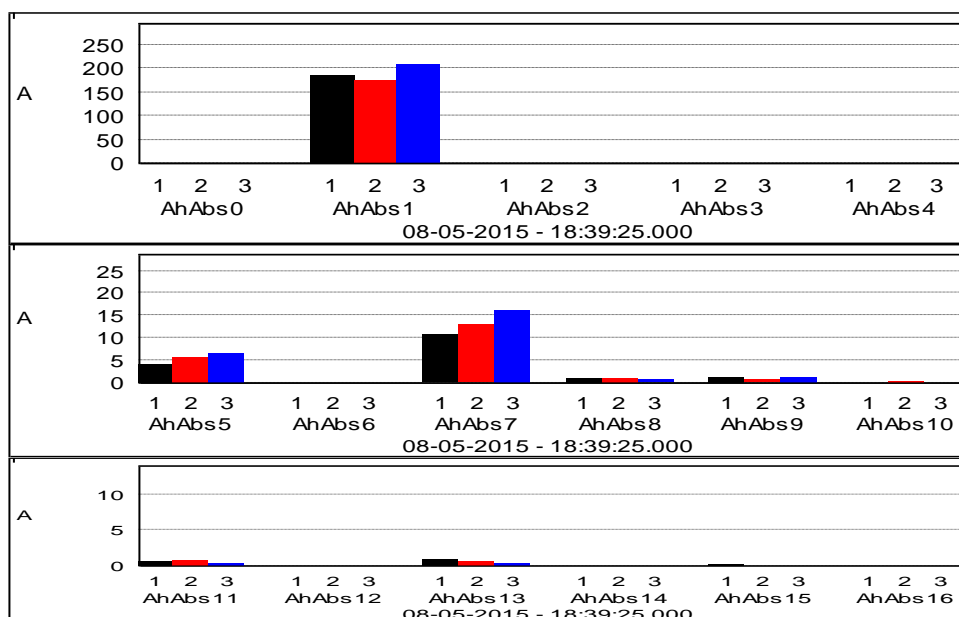
Transformer 2 (Machine Shop)

- 1) Voltage remains within 390V to 430V RMS with tap-changer upstream. Voltage harmonic distortion is less than 1.7%. These readings are recorded continuously over 24 hours with each reading collected at 1 sec interval. Frequency is stable at around 50Hz.
- 2) This 500KVA transformer handles about 450Amps current and the same is distorted at 17%. So effective current can be considered as 600Amps. **Effective Peak power delivery with these parameters is over 450 KVA..** Most of the time actual RMS wattage handled by this transformer is also almost 250KW.
- 3) The APFC panel maintains reactive power correction within + / -50KVAR level always. Harmonic analysis shows predominance of 5th and 7th harmonic currents. Reflected HT side current harmonics may be slightly less.

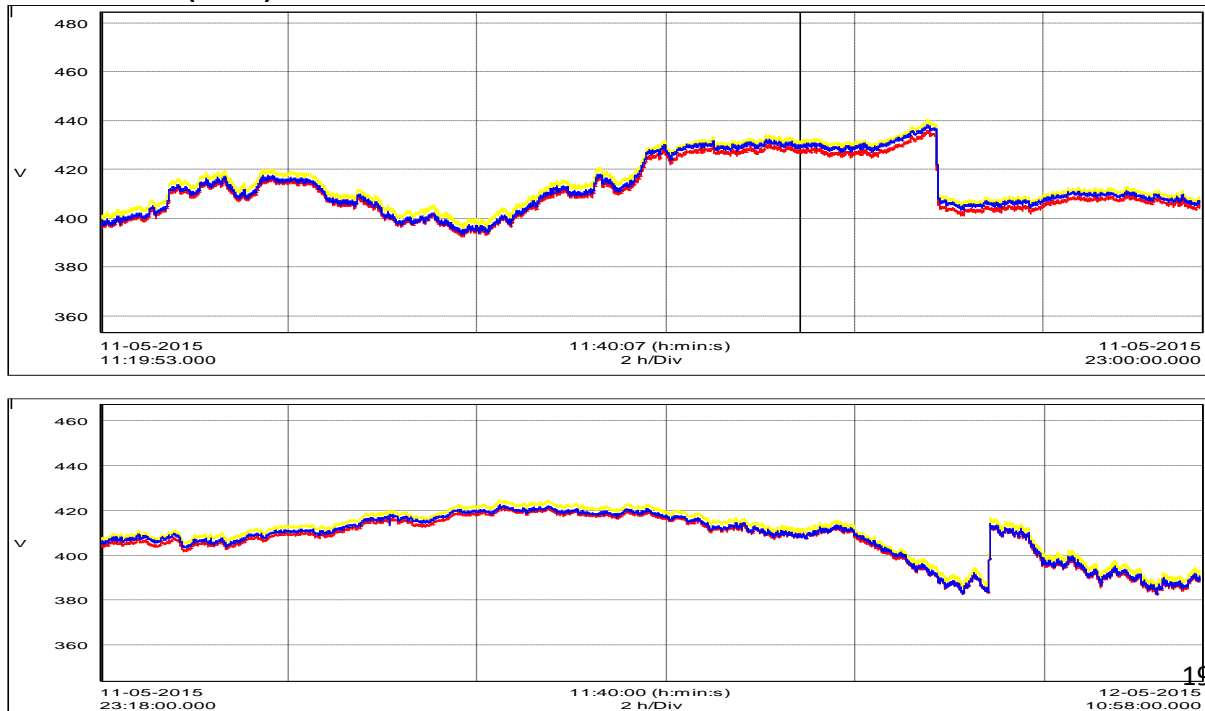
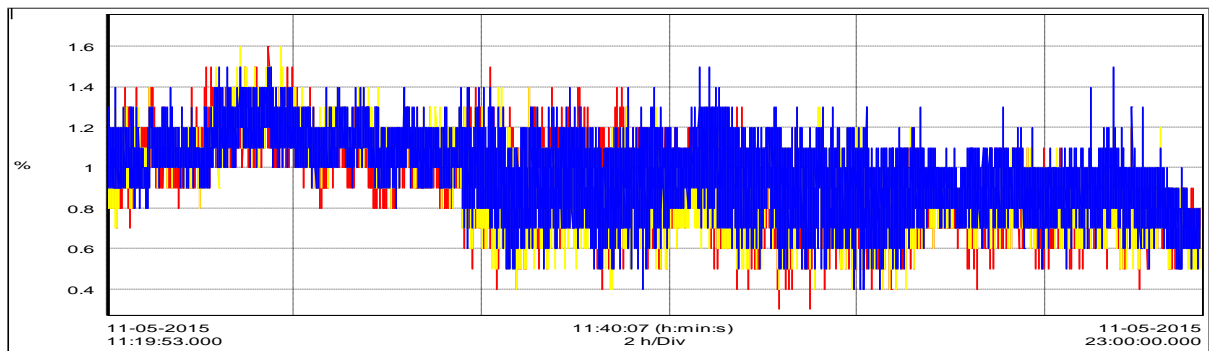
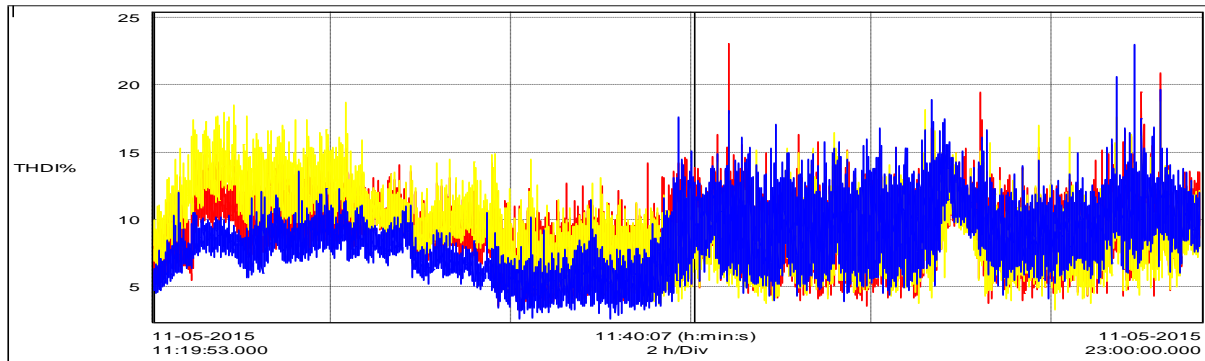
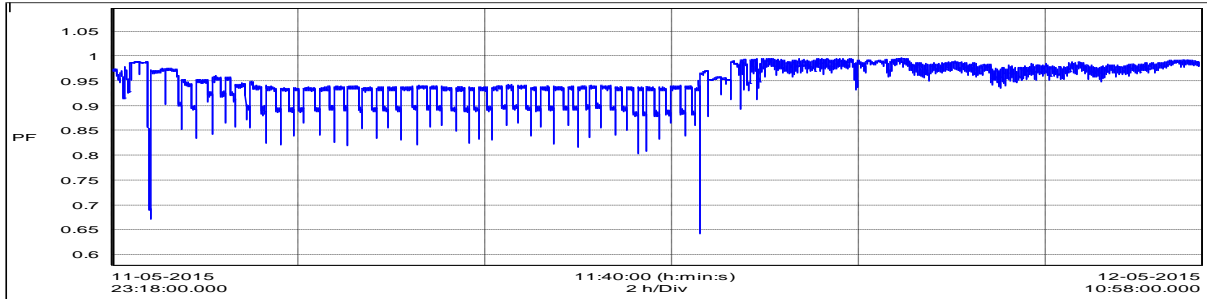
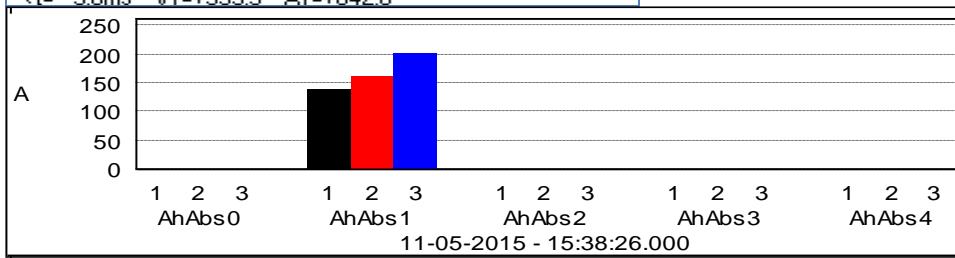
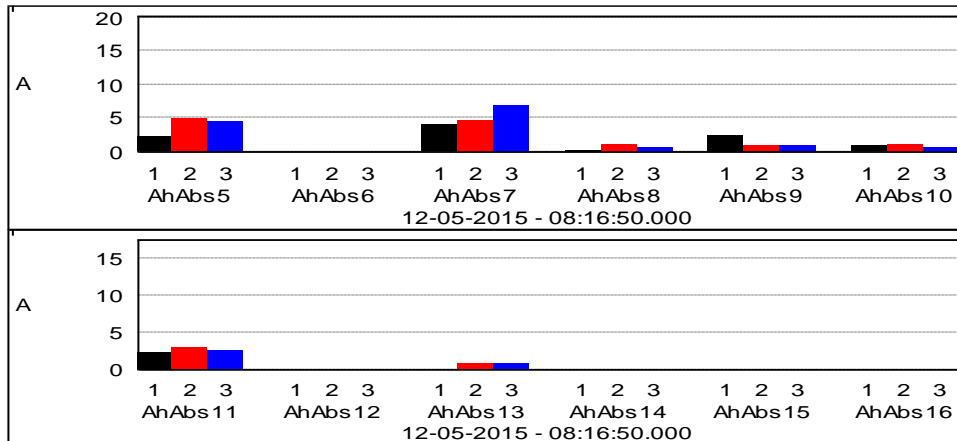
Transformer 3 (PHBA)

- 1) Voltage remains within 380V to 440V RMS with tap-changer upstream. Voltage harmonic distortion is less than 1.6 %. These readings are recorded continuously over 24 hours with each reading collected at 1 sec interval. Frequency is stable at around 50Hz.
- 2) This 500KVA transformer handles about 300Amps current and the same is distorted at 15%. So effective current can be considered as 450 Amps. **Effective Peak power delivery with these parameters is over 350 KVA.** Most of the time actual RMS wattage handled by this transformer is also almost 150 KW.
- 3) The APFC panel maintains reactive power correction to -50KVAR level always. Harmonic analysis shows predominance of 5th and 7th harmonic currents. Reflected HT side current harmonics may be slightly less.

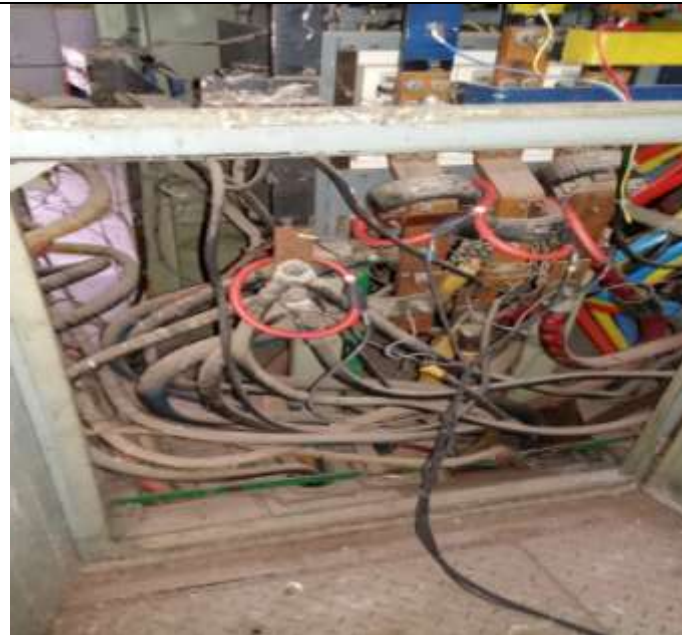
Transformer Oil Leakage

- 2) 3 x 500 KVA transformers need “Factory overhauling” to address oil leakage and other related issues. This may be done by disconnecting one transformer at a time. We advice this should be done before increasing the load through expansion. Transformer 1 is overloaded. You may shift one compressor on transformer 3.

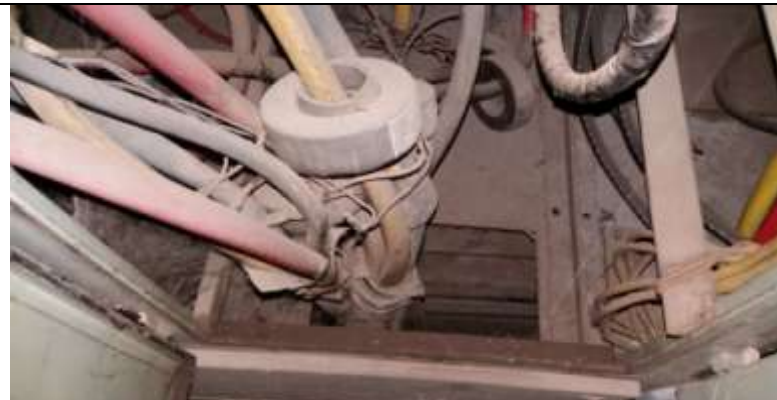
Main cable termination in LT panels

At present terminations as shown in IR Thermography report need to be attended immediately to avoid loose contact and possible flashovers.
