ELECTRICAL LOAD STUDY & POWER QUALITY ANALYSIS REPORT

**AUTOMOTIVE COMPONENT
MANUFACTURING COMPANY**

SAS Powertech Pvt Ltd.

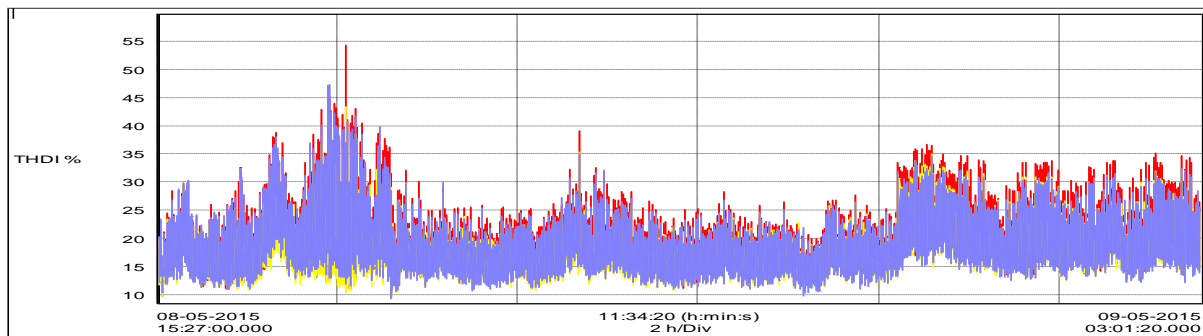
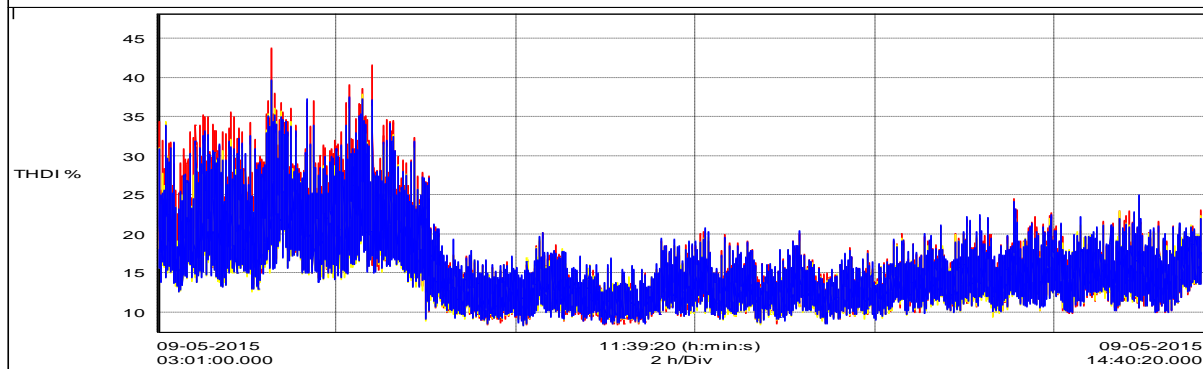
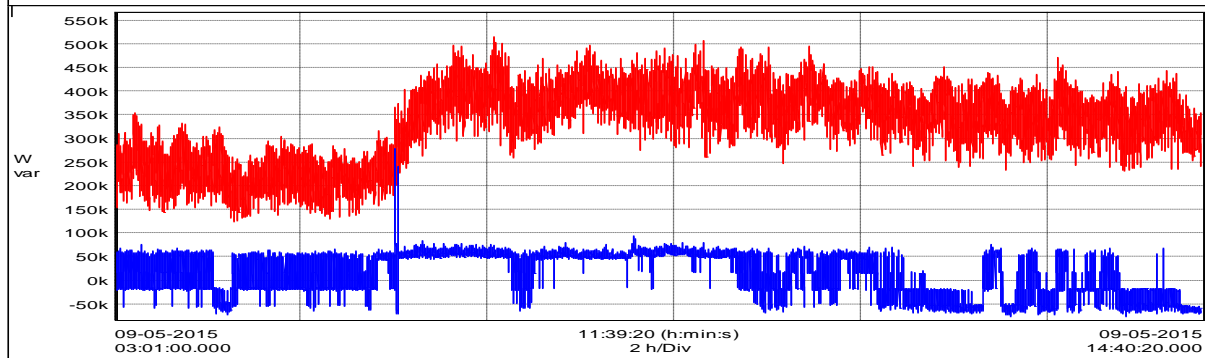
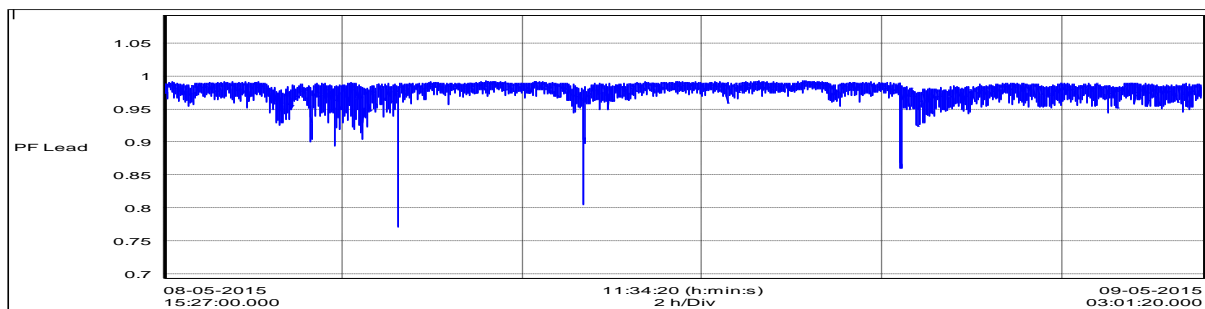
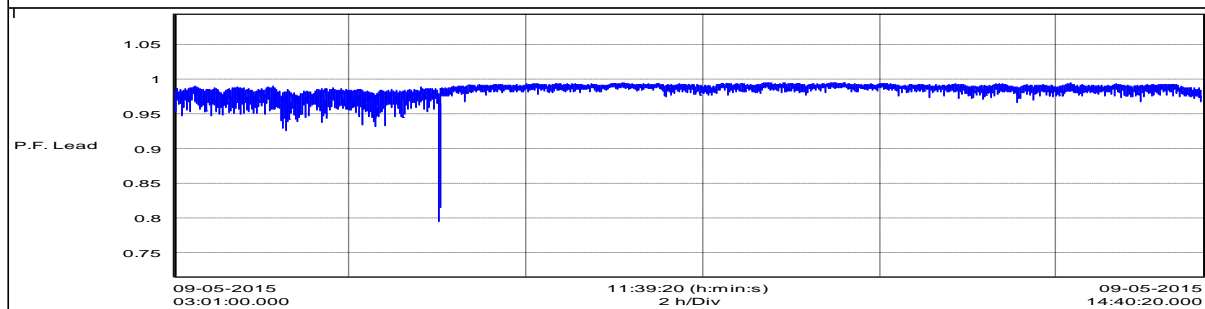
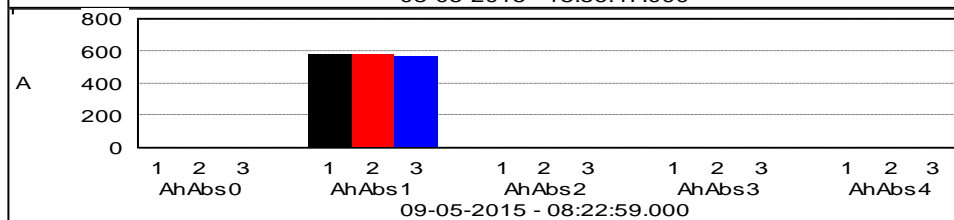
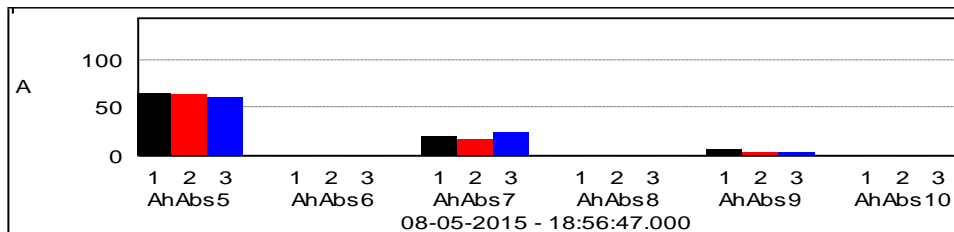
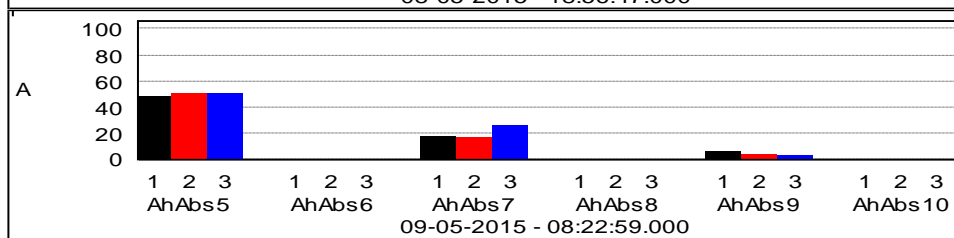
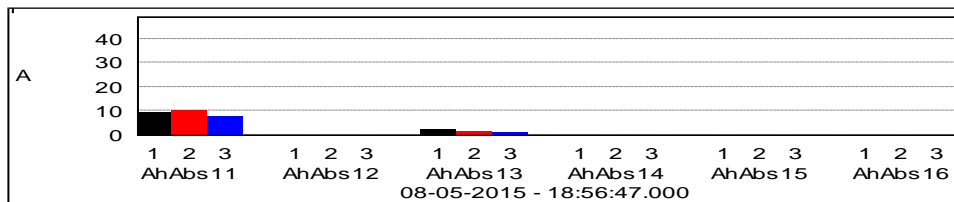
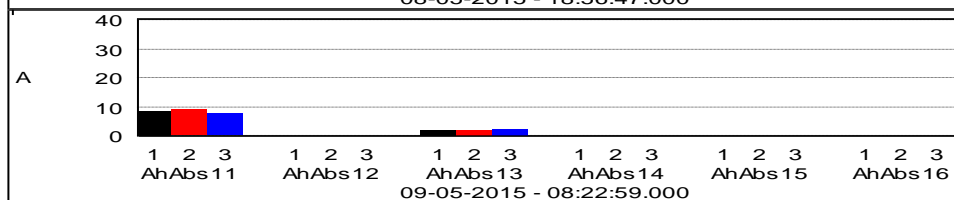
Transformer 1 (PDC)

- 1) Voltage remains within 400V to 450V RMS with tap-changer upstream. Voltage harmonic distortion is less than 3.5%. These readings are recorded continuously over 24 hours with each reading collected at 1 sec interval. Frequency is stable at around 50Hz.
- 2) This 500KVA transformer handles about 750Amps current and the same is distorted at 25%. So effective current can be considered as 900Amps. **Effective Peak power delivery with these parameters is over 600 KVA. This transformer is clearly overloaded.** Most of the time actual RMS wattage handled by this transformer is also almost 450KW.
- 3) The APFC panel maintains reactive power correction to -50KVAR level always. Harmonic analysis shows predominance of 5th and 7th harmonic currents. Reflected HT side current harmonics may be slightly less.

- It is also observed that about 200KW load is related to compressors which are working on transformer 1 along with other PDC Load. This may be split within other transformers, so that Transformer 1 will not get overloaded.

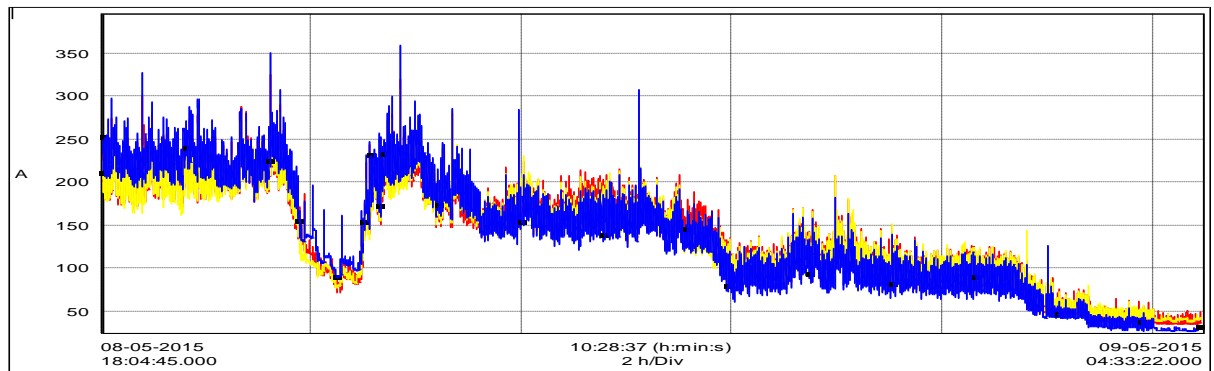
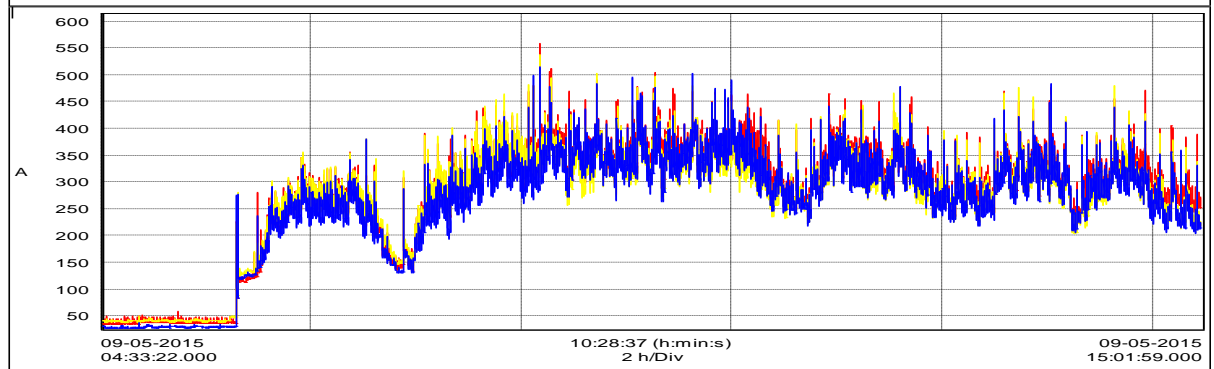
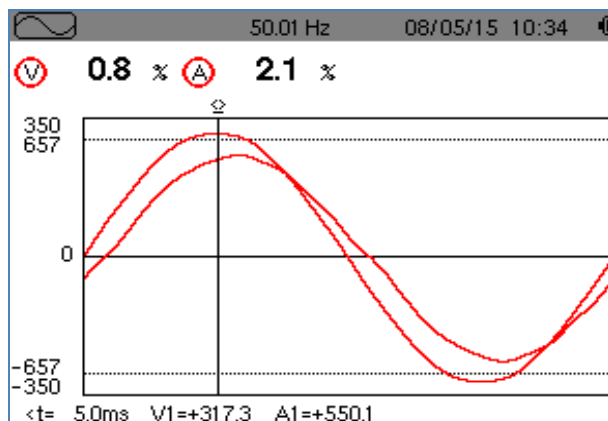
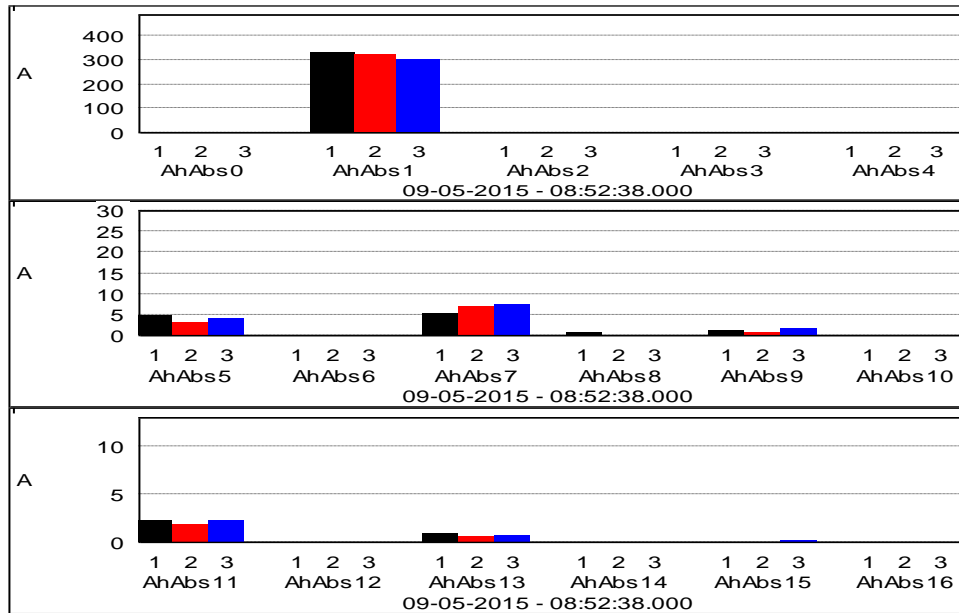
Transformer 2 (Machine Shop)

- 1) Voltage remains within 390V to 430V RMS with tap-changer upstream. Voltage harmonic distortion is less than 1.7%. These readings are recorded continuously over 24 hours with each reading collected at 1 sec interval. Frequency is stable at around 50Hz.
- 2) This 500KVA transformer handles about 450Amps current and the same is distorted at 17%. So effective current can be considered as 600Amps. **Effective Peak power delivery with these parameters is over 450 KVA..** Most of the time actual RMS wattage handled by this transformer is also almost 250KW.
- 3) The APFC panel maintains reactive power correction within + / -50KVAR level always. Harmonic analysis shows predominance of 5th and 7th harmonic currents. Reflected HT side current harmonics may be slightly less.
